Docket No. 217 – Development and Management Plan Inspection

Northeast Utilities Service Company Certificate of Environmental Compatibility and Public Need for the construction of a 345-kV electric transmission line and reconstruction of an existing 115-kV electric transmission line between Connecticut Light and Power Company's Plumtree Substation in Bethel, through the towns of Redding, Weston, and Wilton, and to the Norwalk Substation in Norwalk, Connecticut.

Date: February 13, 2004

Location: Norwalk Substation Expansion

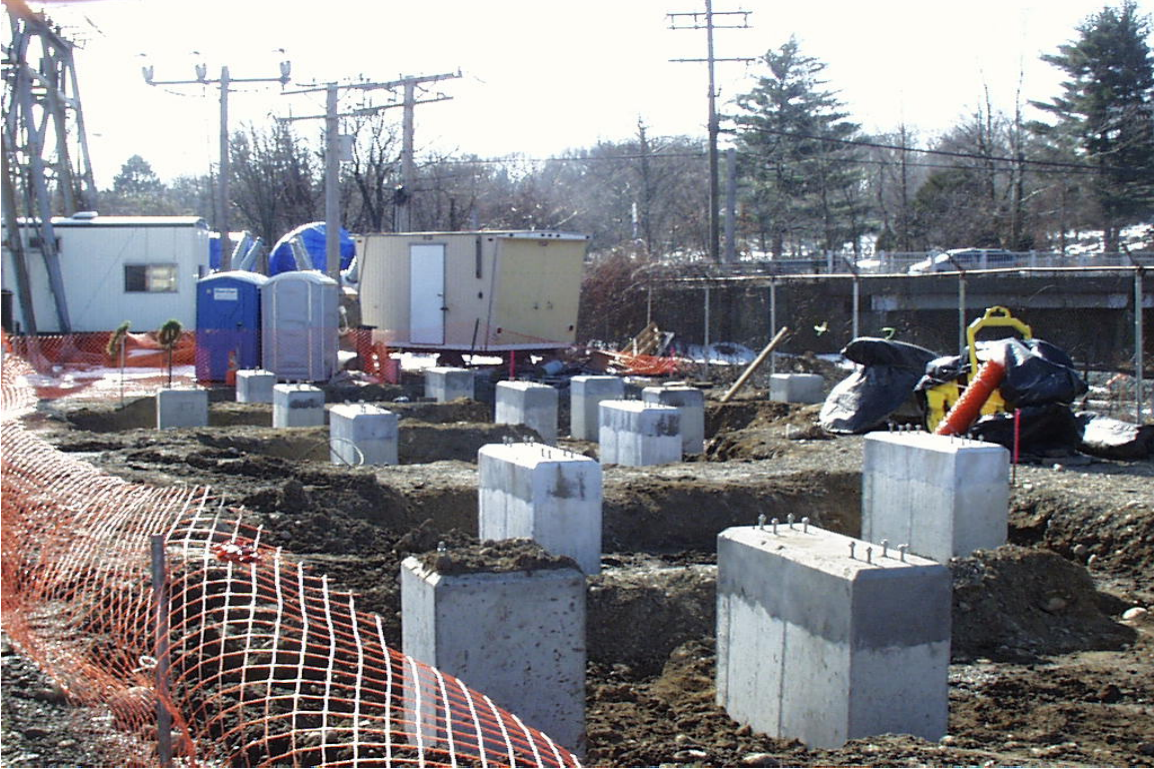
VIEW OF EXCAVATIONS AND FOUNDATION CONSTRUCTION. ALL SOILS ARE WELL CONTROLLED IN THIS LOCATION 2/13/04

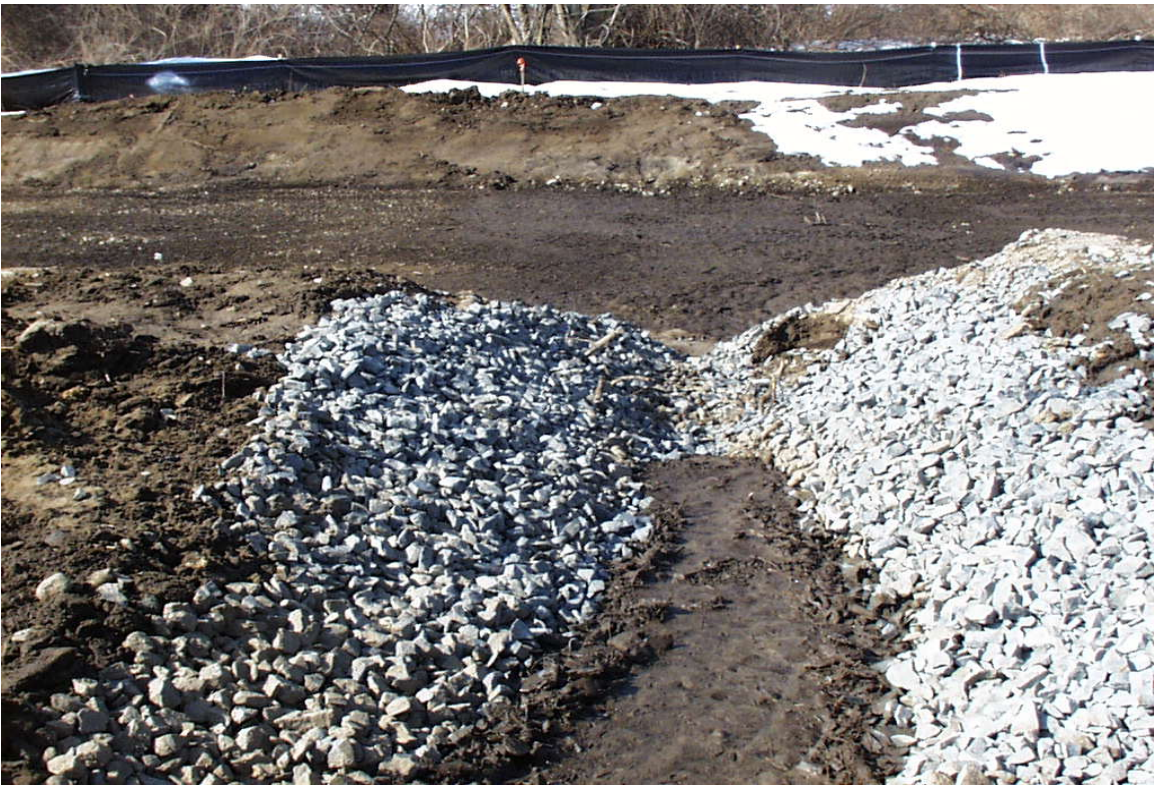
RUNOFF FROM THE MUDDY ACCESS ROAD IS ENTERING THE BASIN. IT IS WORKING AS INSPECTED BUT A HAYBALE CHECK DAM MAY PROLONG THE LIFE OF THE BASIN. 2/13/04

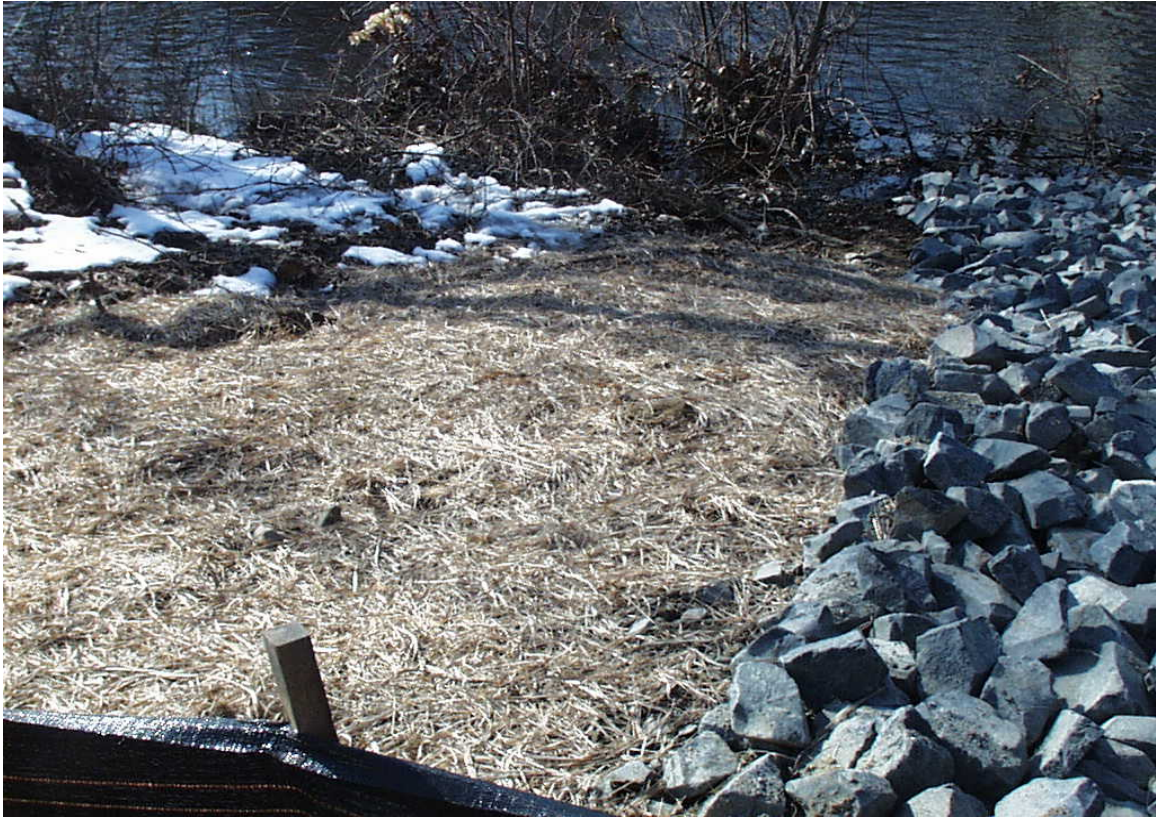
THE EXPOSED SOIL ON THE BANK BY THE RIPRAP OUTLET SWALE HAS BEEN MULCHED WITH HAY. 2/13/04

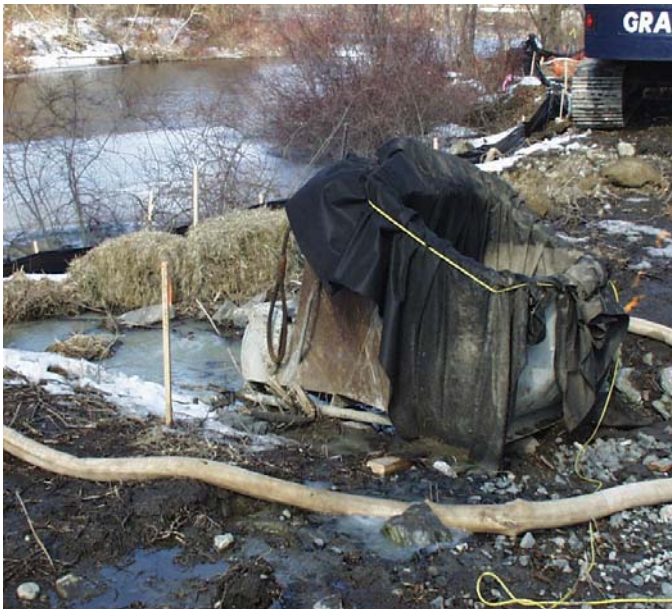
VIEW OF DEWATERING AREA. THE FILTER BEYOND THE SILT BAG WAS ABANDONED DUE TO FREEZING AMOUNTS OF ISSUES. THE VELOCITY OF DISCHARGE WAS GETTING PAST TOO GREAT AND TOO CLOSE TO THE EROSION CONTROL. 2/13/04

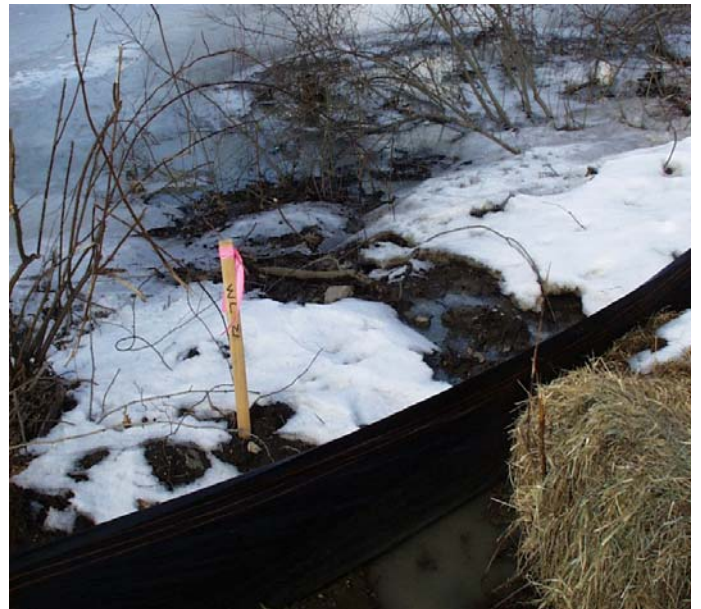
VIEW OF RIVERBANK FENCE. SOME SMALL SEDIMENTS WERE ALL BARRIERS. 2/13/04

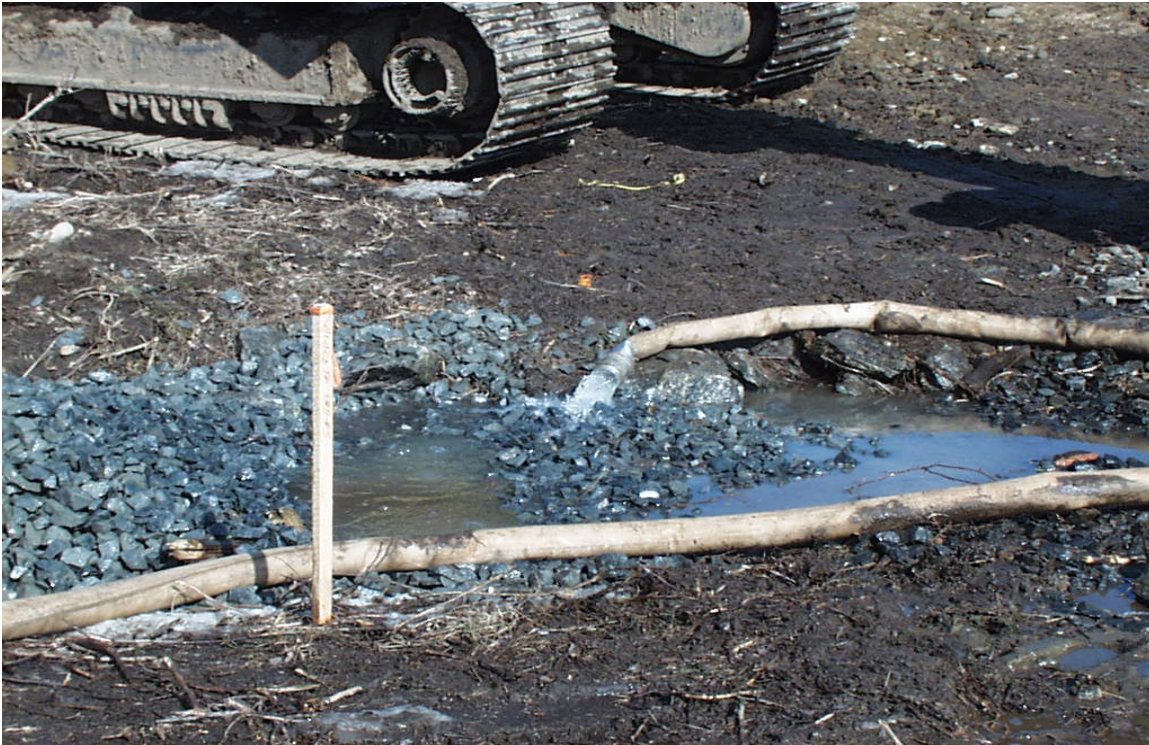
CREWS RESPONDED IMMEDIATELY AND PULLED THE DISCHARGE HOSE FURTHER BACK. THEY BUILT A ROCK BERN AND DISSIPATER AREA. WATER LOOKED CLEARER. 2/13/04

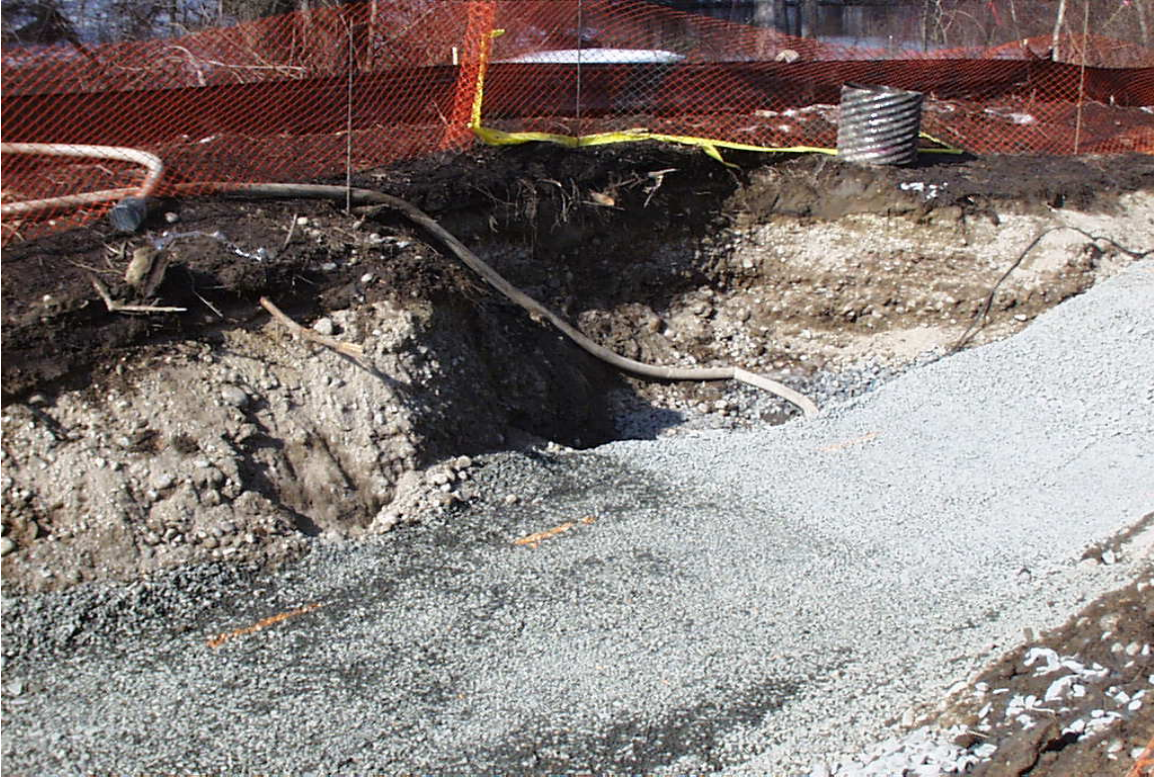
SOURCE OF DEWATERING. THE BASE FOR THE RETAINING WALL MUST BE BUILT IN A FAIRLY DRY ENVIRONMENT AND WATER LEVELS WERE HIGH. 2/13/04

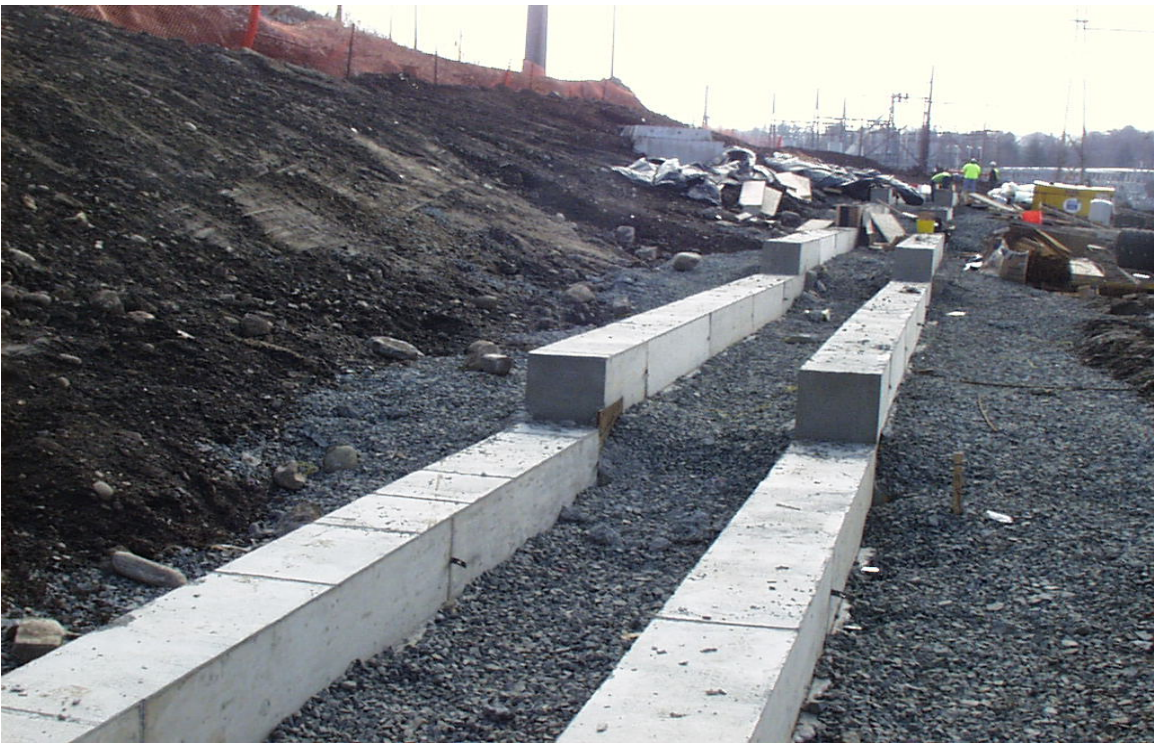
FOUNDATIONS FOR RETAINING WALL IN AREA OF RECENT SOIL EXCAVATION.
2/13/04

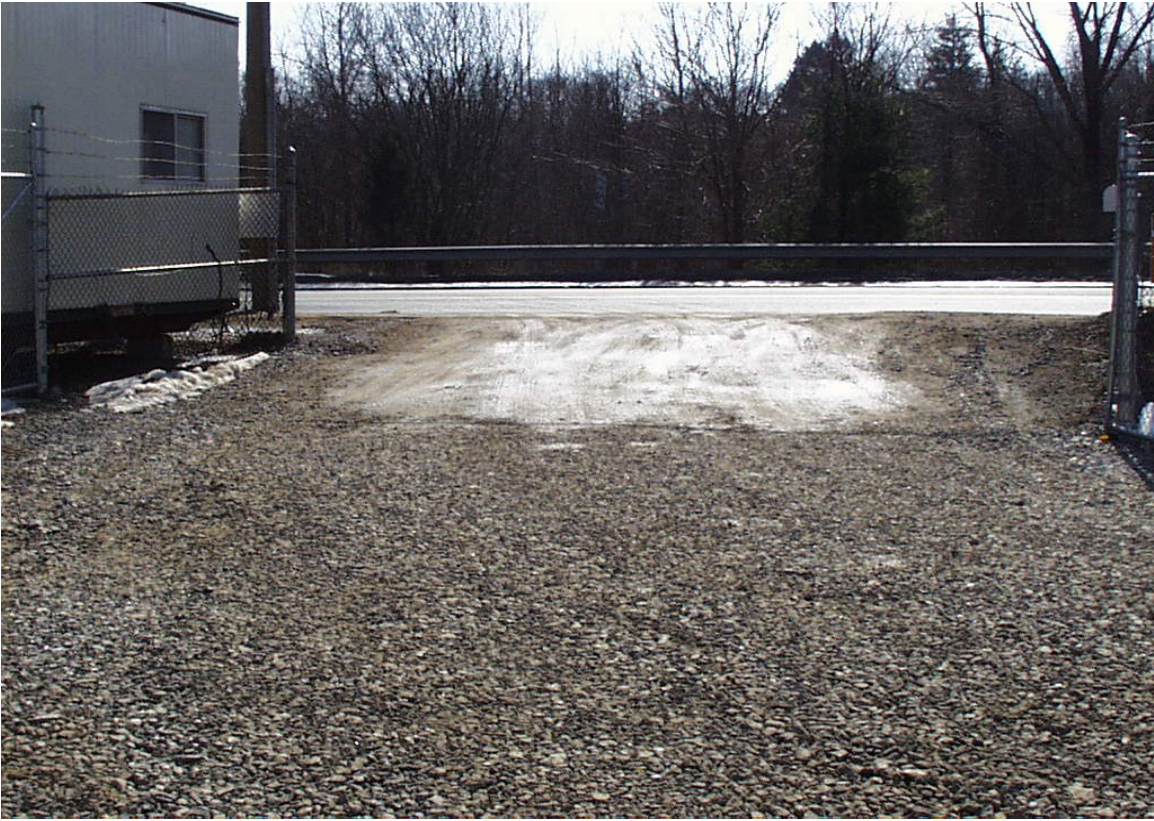
VIEW OF CLEAN GRAVEL PAD NEAR NEW CANAAN AVENUE. 2/13/04
